Radon in Air Testing Report

Red Deer Catholic Regional Schools

Red Deer Catholic Regional Schools 2018/2019

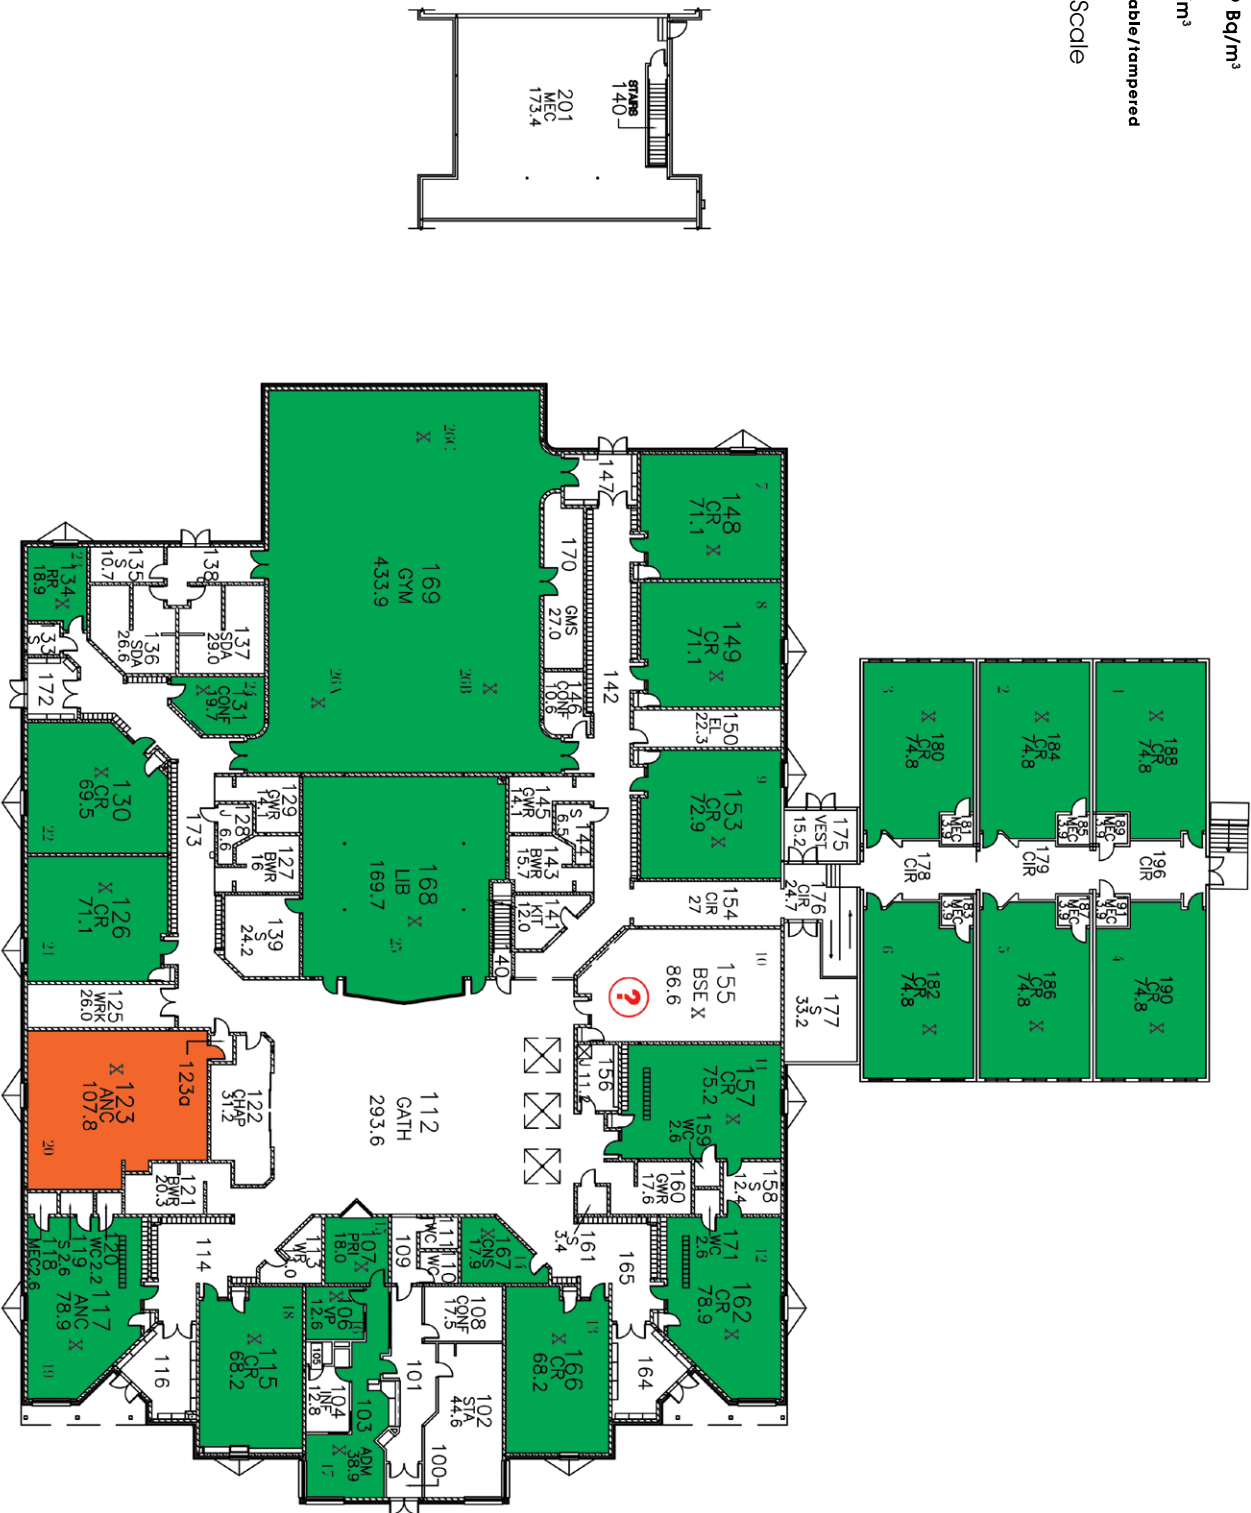
Table 3.9 **Our Lady of the Rosary**

LEGEND

- Rooms not measured
- <100 Bq/m³
- 100 - 199 Bq/m³
- >200 Bq/m³
- ? Unrecoverable/tampered

Sampling completed from December 22 2018 to April 13 2019 indicate Room 117 at a slightly elevated level of 148 Bq/m³ but which is still below current Health Canada radon action level guidelines.

RadonCare encourages additional testing of this room using a CRM monitoring device to determine level fluctuations and obtain a better understanding of radon exposure during occupancy (as opposed to overnight and other periods of non-occupation) which are contributing to human exposure.

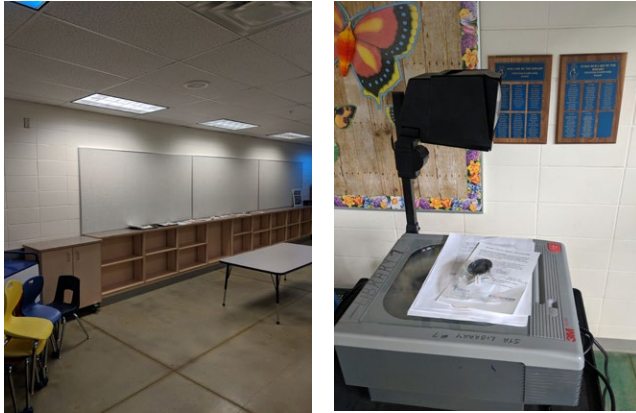
Dosimeter 10-155-39121139 was unrecoverable and missing.
Dosimeter 10-155-3912140B, a QC blank was moved outside of sampling location on a projection cart with deployment placard.

Selected room for deployment and location dosimeter 10-155-3912140B found
